LANDSLIDES AND RELATED FEATURES

OF THE STEVENSON, ALA. QUADRANGLE

by
Roger E. Thomas

OPEN FILE MAP 82-193 (C-2)

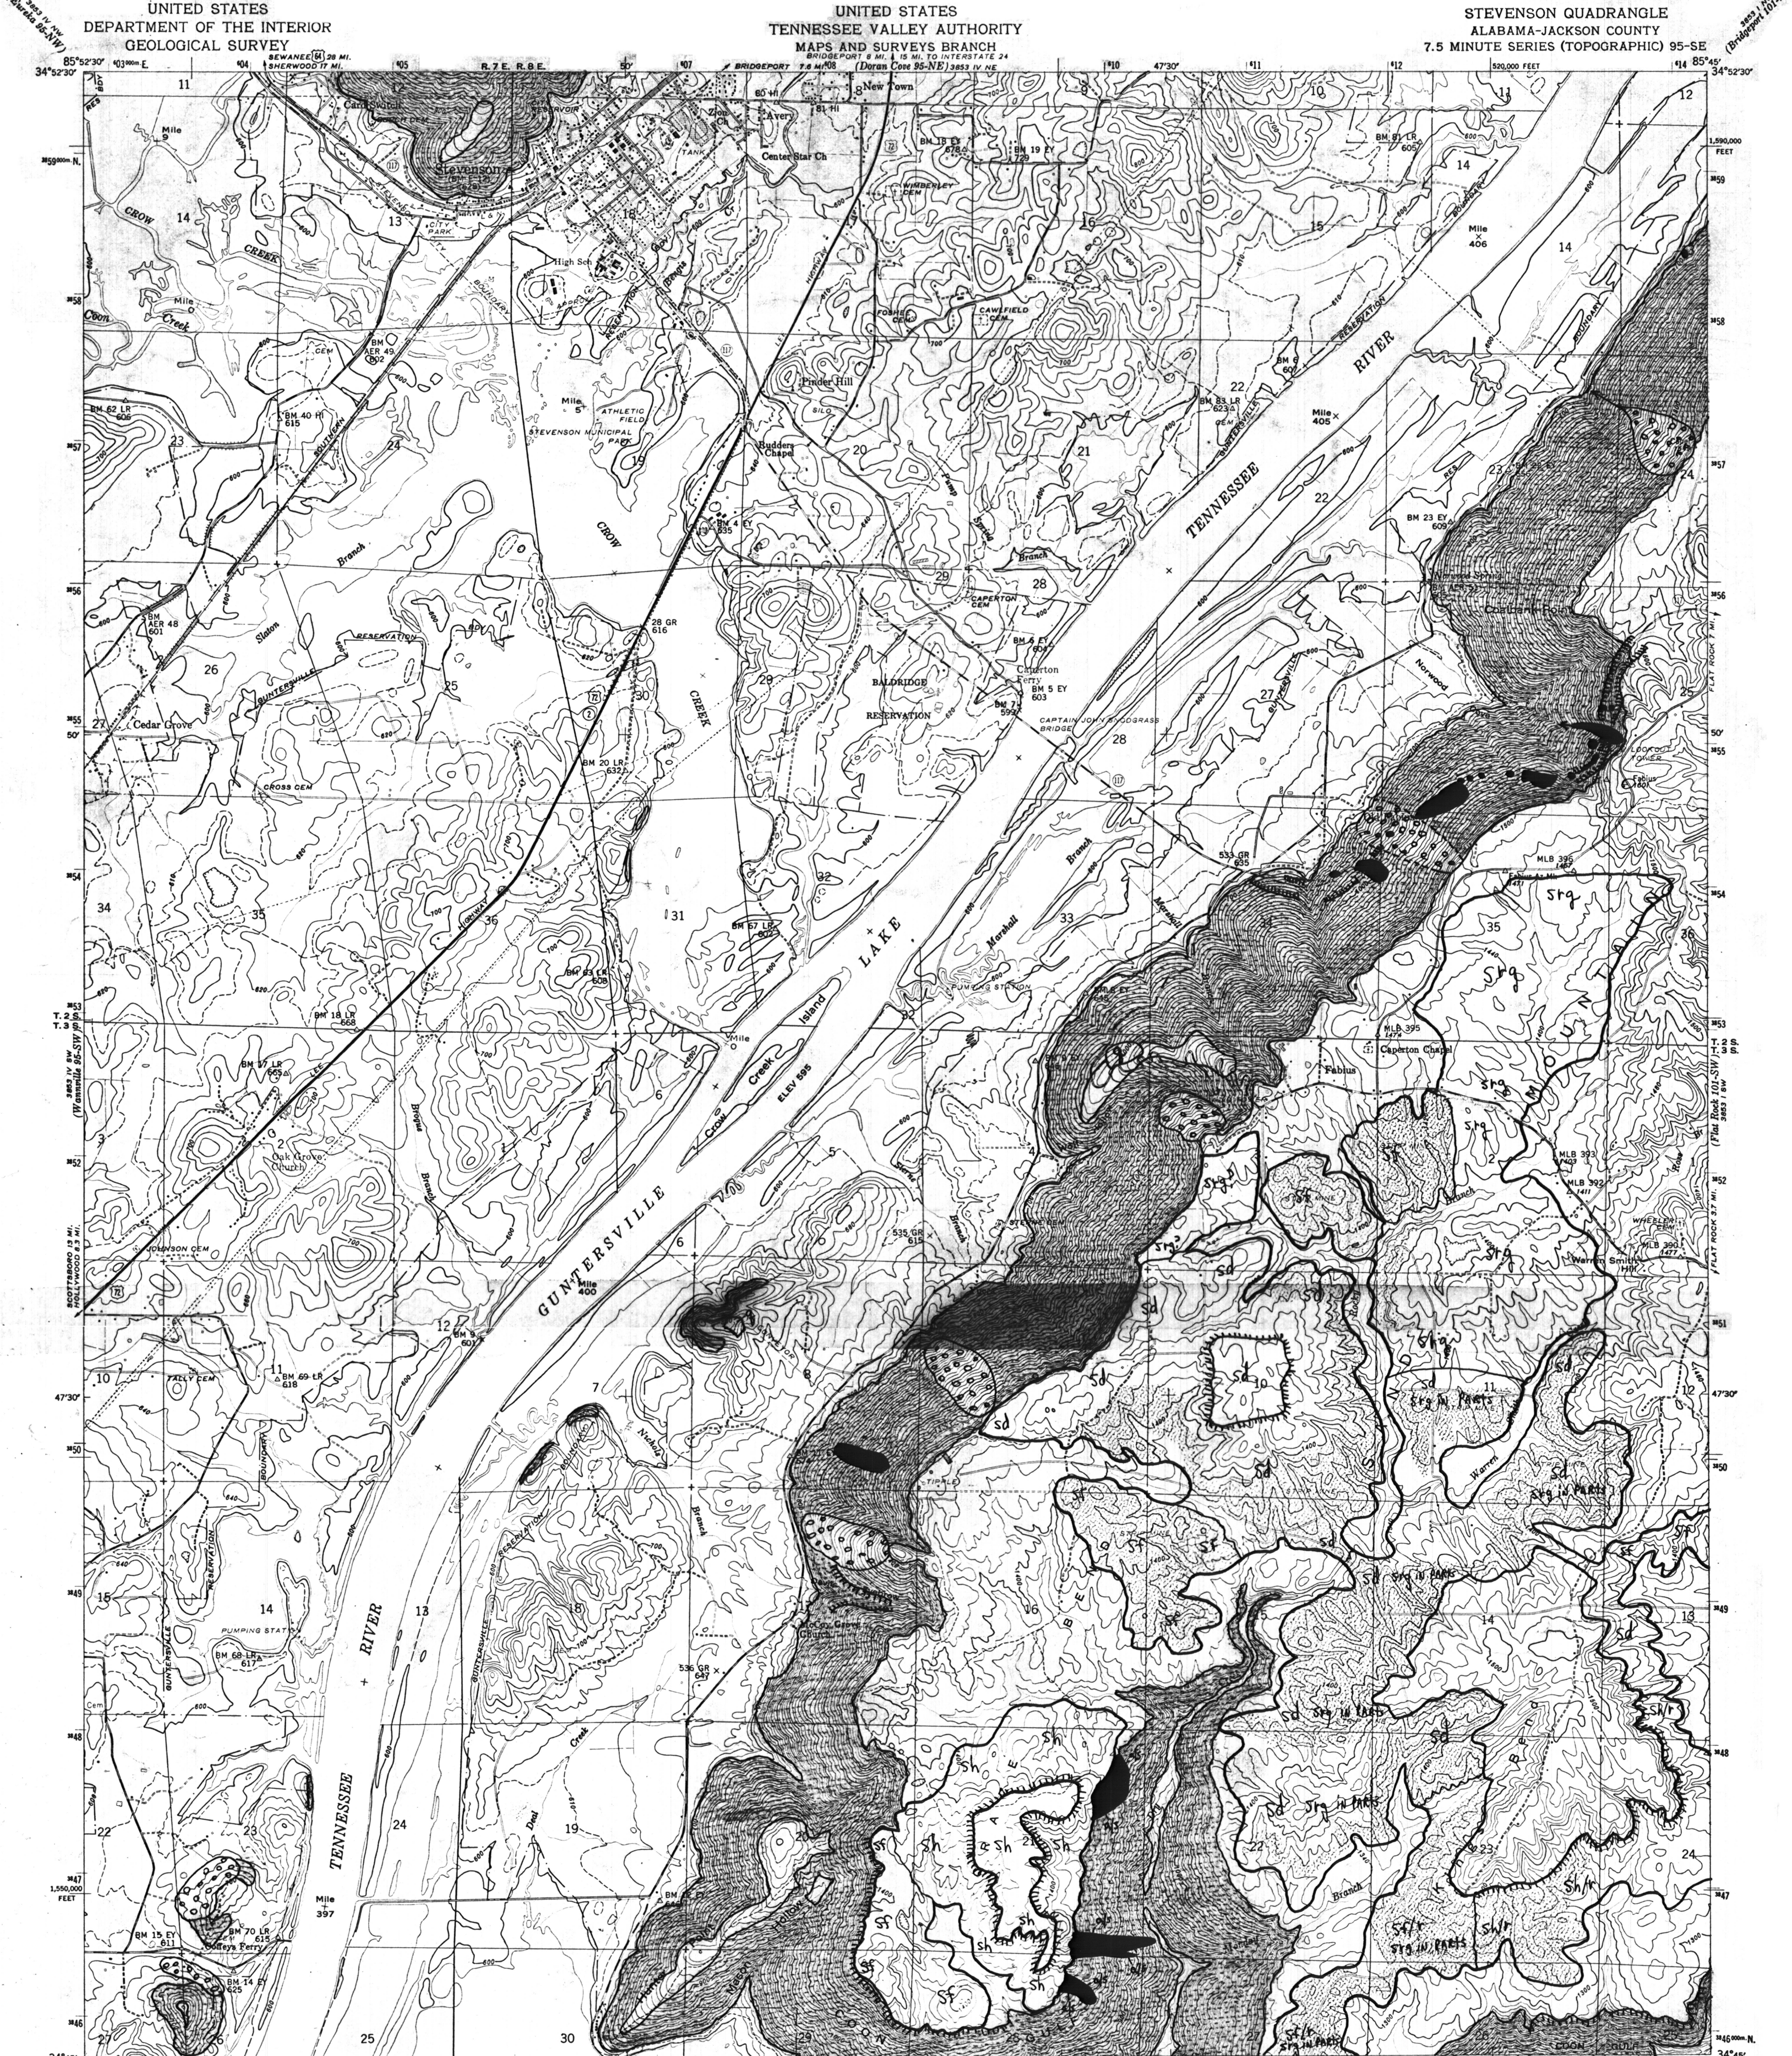
Information shown is intended as a general guide to ground conditions as of the date of field check. Additional landslides and rockfalls should be anticipated in all map units. The map unit depicts the dominant condition in the area delineated and variations in slope stability may occur at any point in the unit. This map is suitable for general planning purposes and as a supplement to more detailed studies for site selection. The map cannot be used as a substitute for detailed geologic and engineering investigations to establish design and construction criteria of specific sites. Some symbols may not appear on this map because the description is applicable to a series of maps.

- ACTIVE OR RECENTLY ACTIVE LANDSLIDE**
Complex landslide composed of earthflow, debris slide, earth and rock slump. Identified from historical records, and from scars, debris and other field evidence. Ground extremely unstable; sliding accelerated by excavation, loading and changes in drainage conditions. May include areas with several active slides too small to be shown separately. Questioned where doubtful.

- OLD LANDSLIDE**
Area of extensive hummocky ground caused by earthflow and earth and rock slump. Lacks clear evidence of active sliding. Relatively stable in natural, undisturbed state, generally not affected by small structures properly sited in areas away from the edge of the toe; can be reactivated by extensive, rapid excavation, loading, and changes in ground water and surface water conditions. Area of old landslide probably includes recent ones not identified from field evidence or otherwise documented. Upslope boundary of landslide generally defined by modified scarp, but downslope (toe) may be gradational and not well defined. Questioned where doubtful.

- COMBINATION LANDSLIDE**
Area of recent and old slides in which individual slides are not identified.
- COLLUVIAL SLOPE**
Valley wall along major streams with slope as steep as 40° (85%); stony, clayey silt soil up to 50 ft. (15 m) thick; commonly buttressed by a terrace or bench at the toe of the slope; very susceptible to sliding by cutting of toe area, removal of terrace or bench, and overloading; slide commonly activated without apparent cause.

- COLLUVIAL SLOPES WITH LANDSLIDES**
Landslides too small or obscure to map individually.
- AREAS SUSCEPTIBLE TO DEBRIS FLOWS AND DEBRIS AVALANCHES**
Primarily shallow, narrow ravines and chutes with accumulation of stony colluvium generally 10 ft. (3 m) or less in thickness; susceptible to rapid movement during intense rainfall. Most ravines and chutes designated show evidence of former debris flows and avalanches.

- AREAS SUSCEPTIBLE TO ROCKFALL**
Steep, locally vertical, natural and man-made slopes and cliffs, 15 ft. (4.5 m) or more high; formed dominantly of sandstone, limestone, sandy shale, mudstone and claystone. Interbedded mudstone, claystone and shale weather rapidly leaving sandstone and limestone rock faces unsupported.

- SOIL AND ROCK SUSCEPTIBLE TO LANDSLIDING**
Soil and rock similar to that involved in landslides elsewhere in map area; primarily areas underlain by claystone, mudstone and shale associated with other rock types. Rock weathers rapidly on exposure forming clayey soil highly susceptible to sliding. Includes coves (U-shaped, shallow valleys) containing thick layers of clayey soil that are very susceptible to sliding where excavation breaks continuity of slope and where overloaded by artificial fill.

AREAS LEAST PRONE TO LANDSLIDES
Map areas in which no patterns or symbols are shown; primarily valley floors, ridge tops and broad benches; modification by excavation and fill may lead to local landslides.

- MAN-MADE FEATURES**
Strip mines (combination of letter symbols indicates complex formed of more than one type of strip mine)
- sh bench with high wall
 - sf furrowed with high wall
 - sd multiple furrows and multiple benches
 - ss hilltop removed
 - srg reclaimed by grading
 - sru reclaimed by secondary use
 - sh/r regraded in part, high wall remains
- Coal refuse banks**
- r identified on aerial photographs; not classified in field check
 - rb not burnt nor on fire
 - rbb burnt
 - rbd burning
 - rbs sludge
- Quarries**
- q quarry site
- Gravel pits**
- g site of gravel pit
- Slides in man-made features**
- af earth flow in fill
 - a/s earth flow in strip castings
 - a/r earth flow in coal refuse
